APPENDIX B

PHOTOGRAPHS

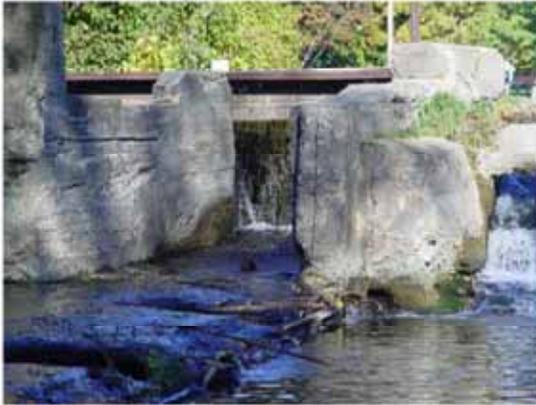
Name: DSC00029
Date Modified: 10/20/2005 10:21:24 AM
Date: 10/27/2005 8:23:46 AM
Description: Stop log bay

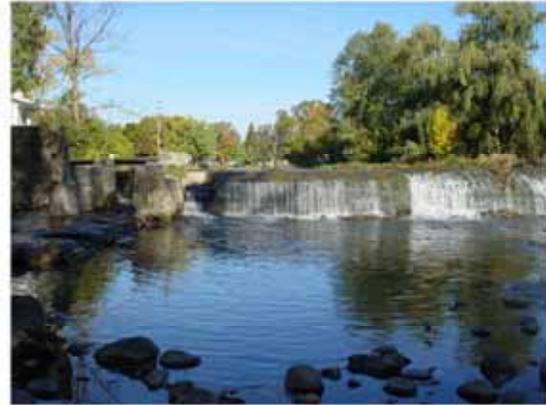
Name: DSC00030
Date Modified: 10/20/2005 10:21:34 AM
Date: 10/27/2005 8:23:42 AM
Description: West portion viewed downstream

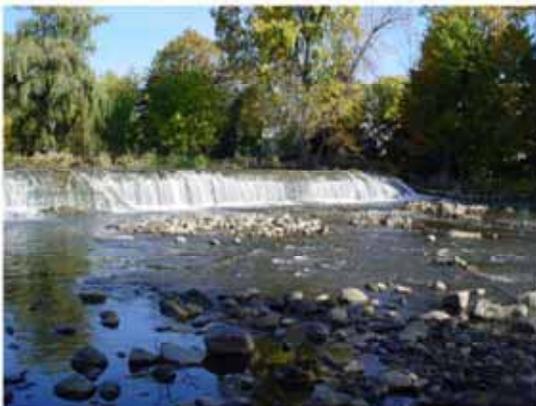
Name: DSC00031
Date Modified: 10/20/2005 10:21:40 AM
Date: 10/27/2005 8:23:42 AM
Description: East portion viewed downstream

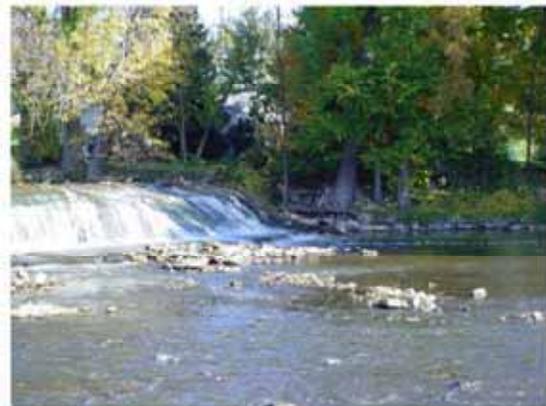
Name: DSC00032
Date Modified: 10/20/2005 10:22:10 AM
Date: 10/27/2005 8:23:42 AM
Description: East portion viewed downstream

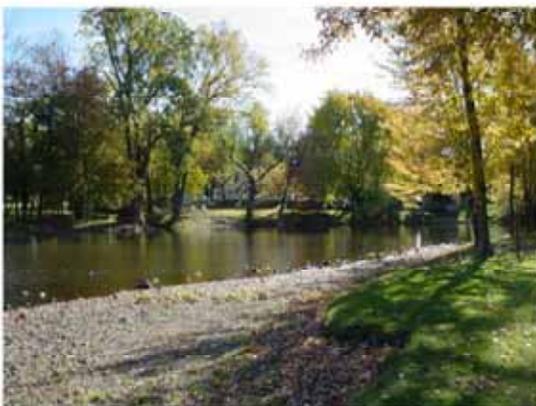
Name: DSC00033
Date Modified: 10/20/2005 10:22:20 AM
Date: 10/27/2005 8:23:44 AM
Description: Downstream of dam

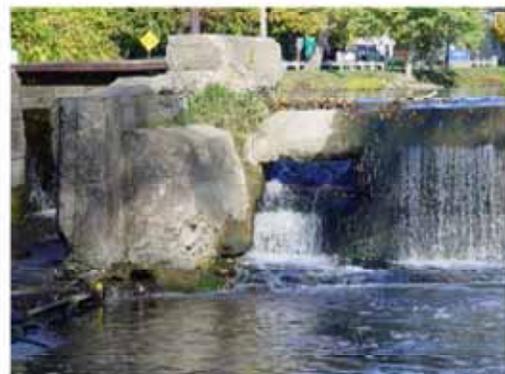
Name: DSC00035
Date Modified: 10/20/2005 10:22:48 AM
Date: 10/27/2005 8:23:44 AM
Description: Hole cut through spillway adjacent to stoplog bays

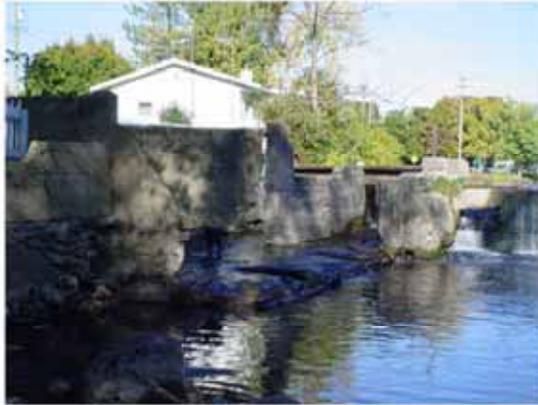
Name: DSC00036
Date Modified: 10/20/2005 10:23:00 AM
Date: 10/27/2005 8:23:44 AM
Description: Stop log bays

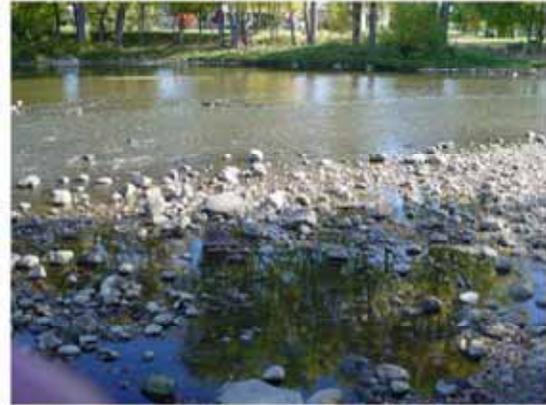
Name: DSC00039
Date Modified: 10/20/2005 10:42:04 AM
Date: 10/27/2005 8:23:46 AM
Description: Riprap deposited just downstream of dam

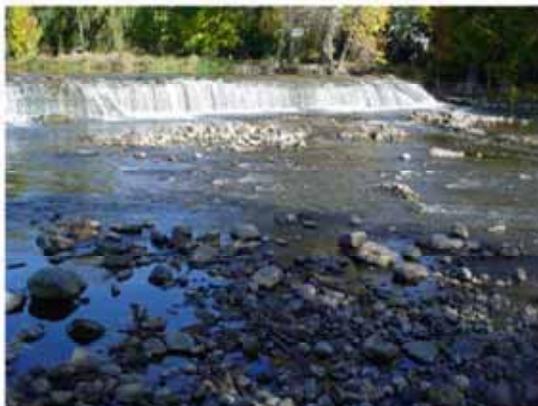
Name: DSC00040
Date Modified: 10/20/2005 10:42:14 AM
Date: 10/27/2005 8:23:46 AM
Description: East portion of spillway

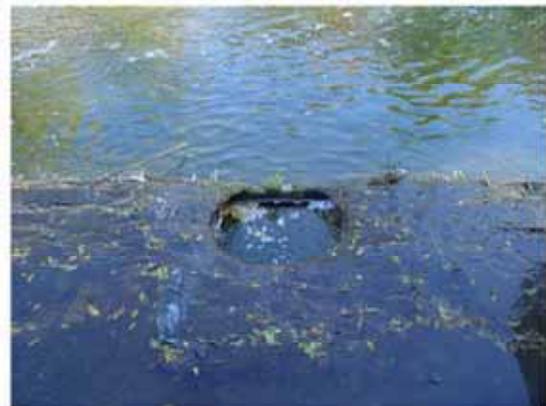
Name: DSC00041
Date Modified: 10/20/2005 10:52:50 AM
Date: 10/27/2005 8:23:42 AM
Description: Outlet of stop log bays

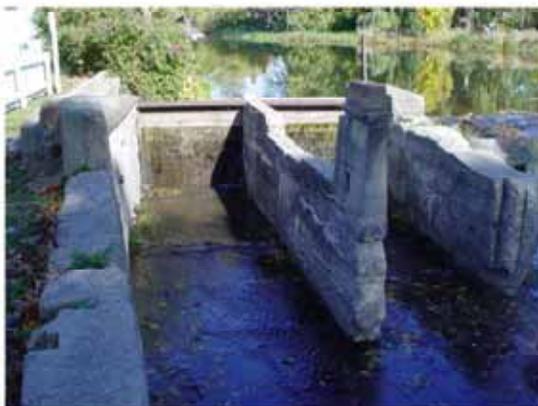
Name: DSC00042
Date Modified: 10/20/2005 10:53:04 AM
Date: 10/27/2005 8:23:46 AM
Description: Stop log bays

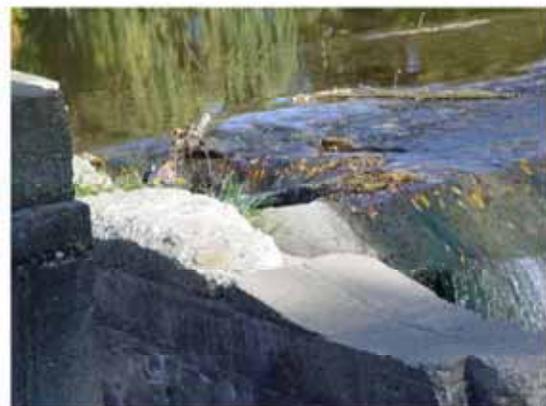
Name: DSC00043
Date Modified: 10/20/2005 10:53:24 AM
Date: 10/27/2005 8:23:46 AM
Description: Spalling concrete

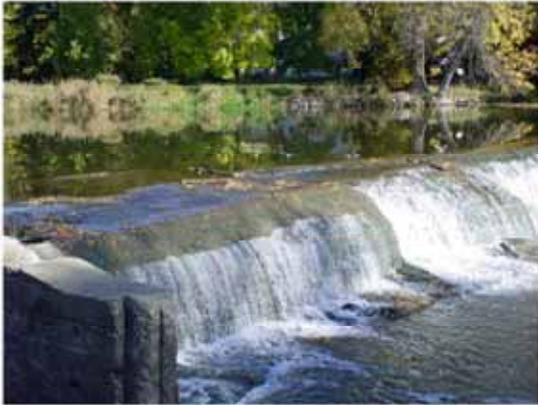
Name: DSC00044
Date Modified: 10/20/2005 10:53:36 AM
Date: 10/27/2005 8:23:46 AM
Description: West portion of spillway

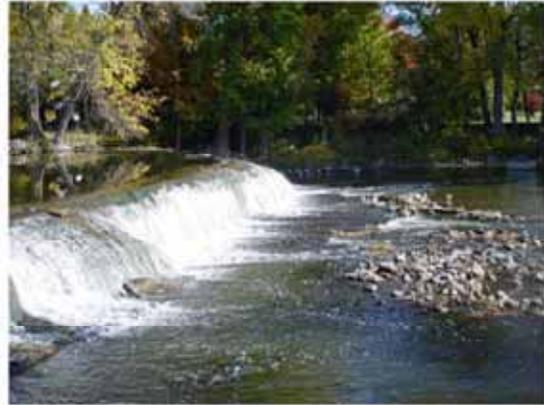
Name: DSC00045
Date Modified: 10/20/2005 10:53:44 AM
Date: 10/27/2005 8:23:46 AM
Description: Spillway

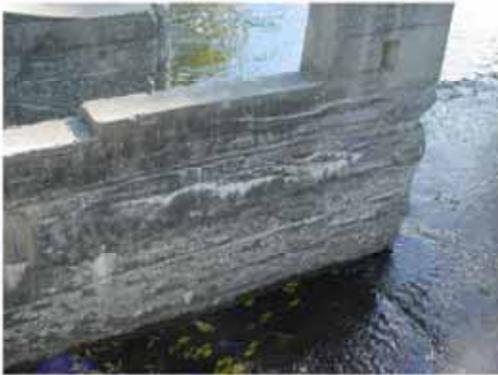
Name: DSC00048
Date Modified: 10/20/2005 10:55:12 AM
Date: 10/27/2005 8:23:48 AM
Description: Efflorescence and cracks in concrete by stop log bays

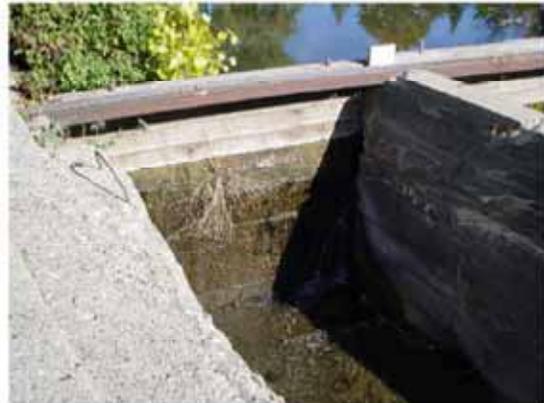
Name: DSC00049
Date Modified: 10/20/2005 10:57:02 AM
Date: 10/27/2005 8:23:48 AM
Description: Stop log bays

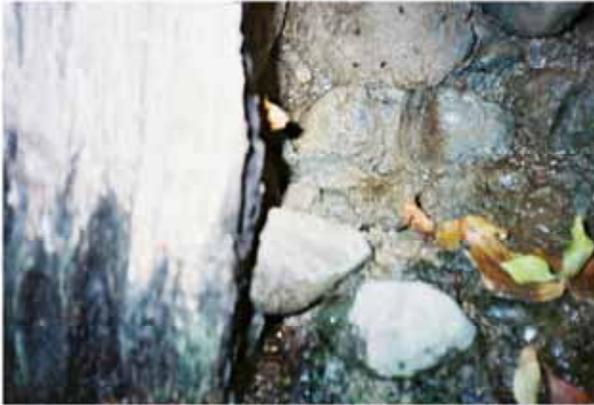
Name: 001_1
Date Modified: 11/1/2005 10:02:52 AM
Date: 10/31/2005 10:56:22 AM
Description: Separation near stop log bays

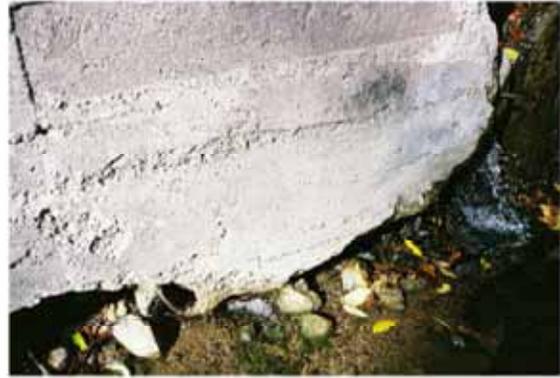
Name: 002_2
Date Modified: 11/1/2005 10:03:04 AM
Date: 10/31/2005 10:56:22 AM
Description: Spalling and deterioration of concrete near stop log bays

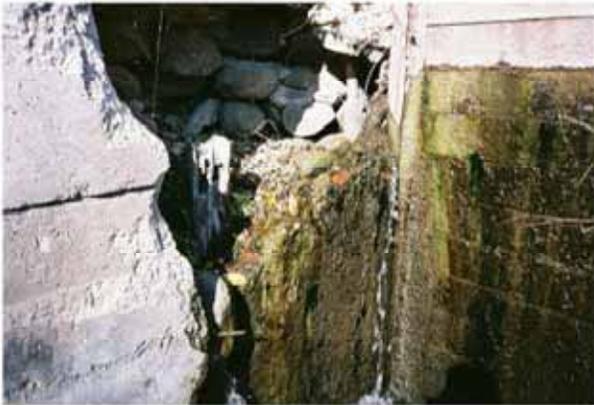
Name: 003_3
Date Modified: 11/1/2005 10:03:14 AM
Date: 10/31/2005 10:56:22 AM
Description: Separation in concrete by stop log bays

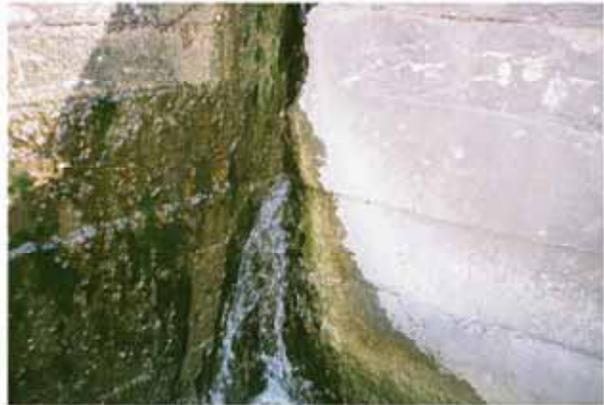
Name: 004_4
Date Modified: 11/1/2005 10:03:26 AM
Date: 10/31/2005 10:56:22 AM
Description: Seepage

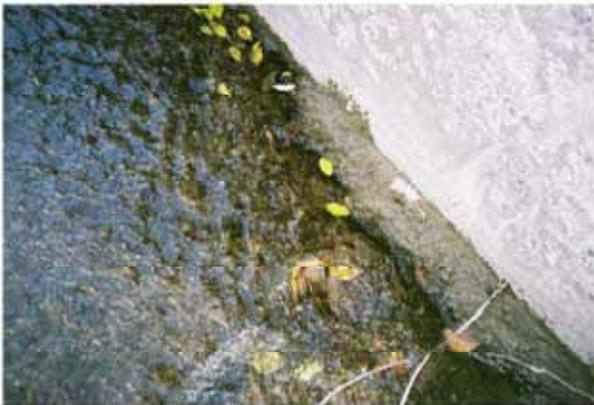
Name: 005_5
Date Modified: 11/1/2005 10:03:38 AM
Date: 10/31/2005 10:56:24 AM
Description: Seepage

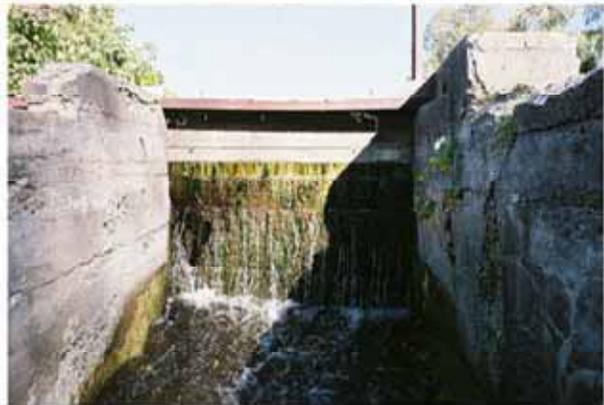
Name: 006_6
Date Modified: 11/1/2005 10:04:58 AM
Date: 10/31/2005 10:56:24 AM
Description: Stop log bay

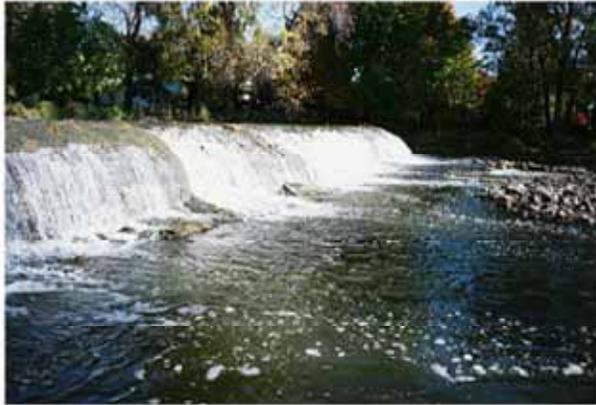
Name: 007_7
Date Modified: 11/1/2005 10:05:00 AM
Date: 10/31/2005 10:56:24 AM
Description: Primary spillway looking East

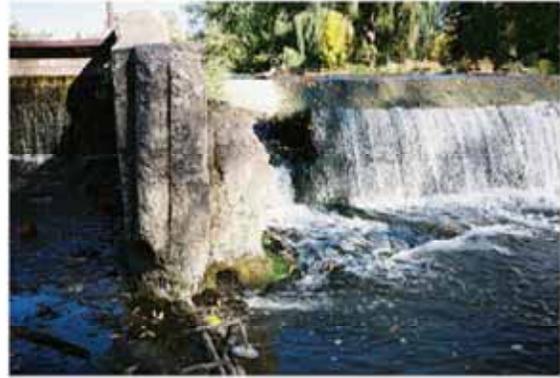
Name: 008_8
Date Modified: 11/1/2005 10:05:00 AM
Date: 10/31/2005 10:56:24 AM
Description: Hole cut through spillway adjacent to stop log bays

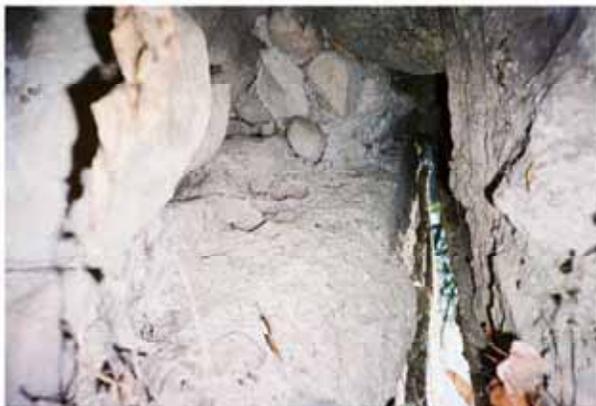
Name: 009_9
Date Modified: 11/1/2005 10:05:02 AM
Date: 10/31/2005 10:56:24 AM
Description: Separation and deterioration of concrete

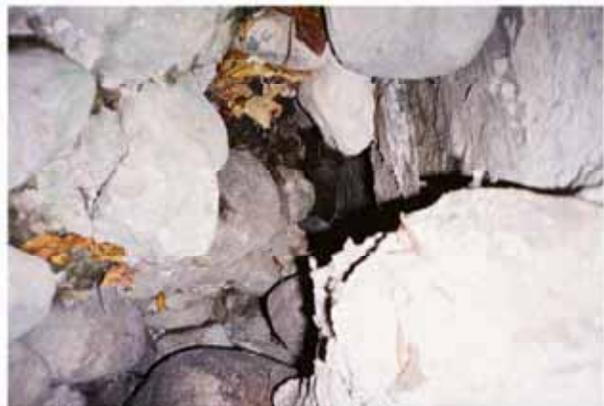
Name: 010_10
Date Modified: 11/1/2005 10:05:04 AM
Date: 10/31/2005 10:56:24 AM
Description: Separation and deterioration of concrete

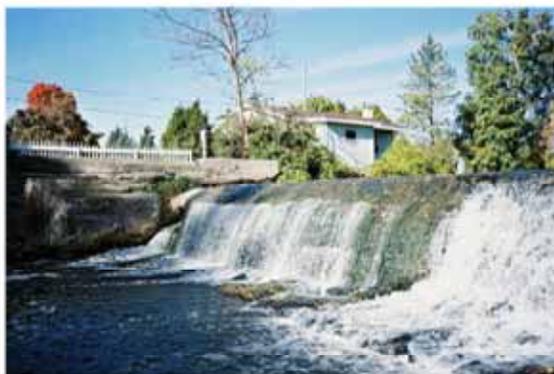
Name: 011_11
Date Modified: 11/1/2005 10:50:10 AM
Date: 10/31/2005 10:56:24 AM
Description: Primary spillway looking West from center of spillway

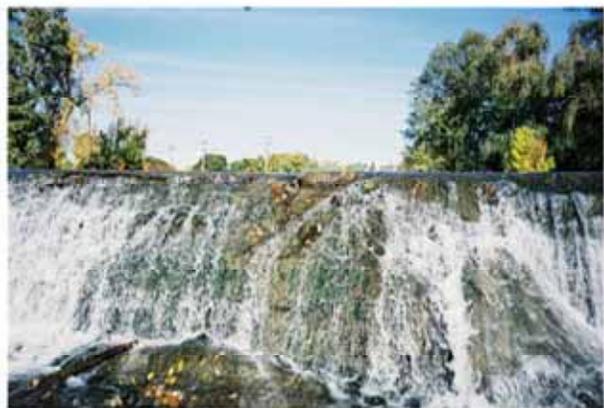
Name: 012_12
Date Modified: 11/1/2005 10:50:10 AM
Date: 10/31/2005 10:56:24 AM
Description: Primary spillway

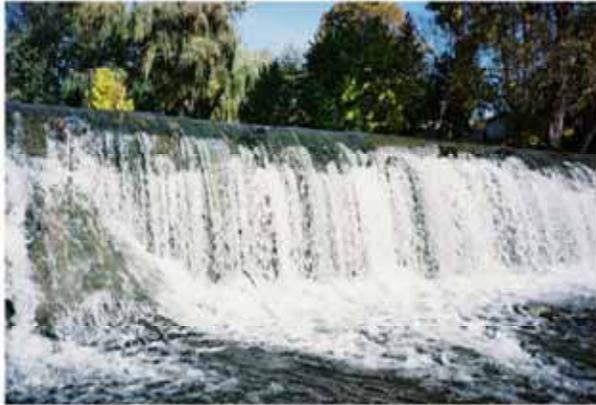
Name: 013_13
Date Modified: 11/1/2005 10:05:08 AM
Date: 10/31/2005 10:56:24 AM
Description: Primary spillway

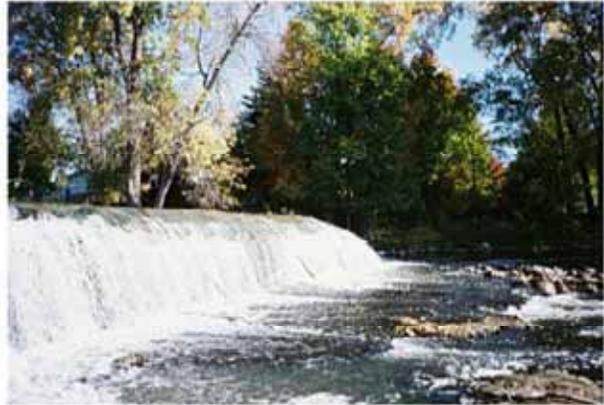
Name: 014_14
Date Modified: 11/1/2005 10:05:08 AM
Date: 10/31/2005 10:56:24 AM
Description: Primary spillway looking East

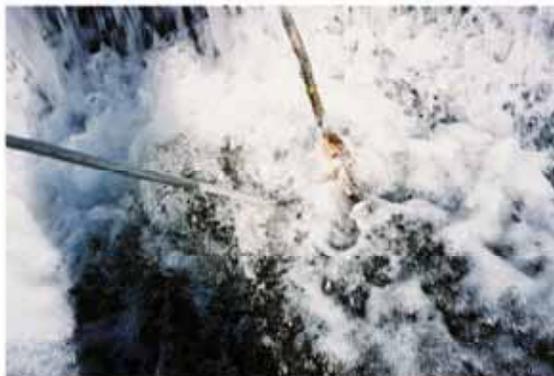
Name: 016_16
Date Modified: 11/1/2005 10:05:12 AM
Date: 10/31/2005 10:56:24 AM
Description: Downstream of spillway boil areas, water seeping under the dam

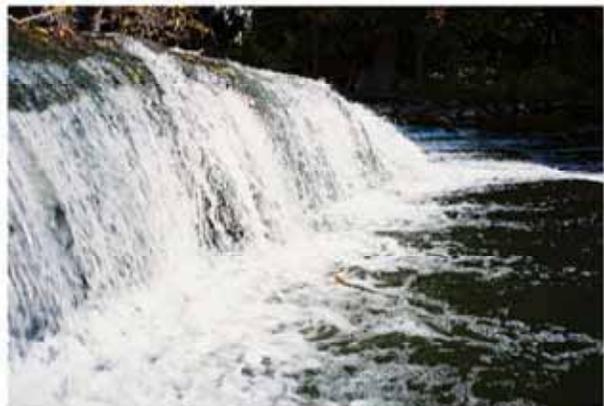
Name: 017_17
Date Modified: 11/1/2005 10:05:30 AM
Date: 10/31/2005 10:56:20 AM
Description: Primary spillway looking East

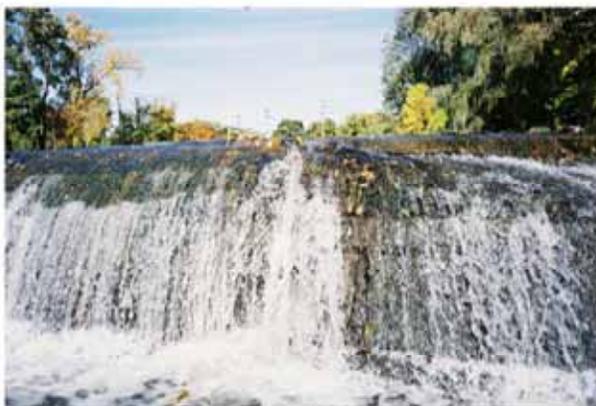
Name: 018_18
Date Modified: 11/1/2005 10:05:32 AM
Date: 10/31/2005 10:56:20 AM
Description: Primary spillway showing deterioration

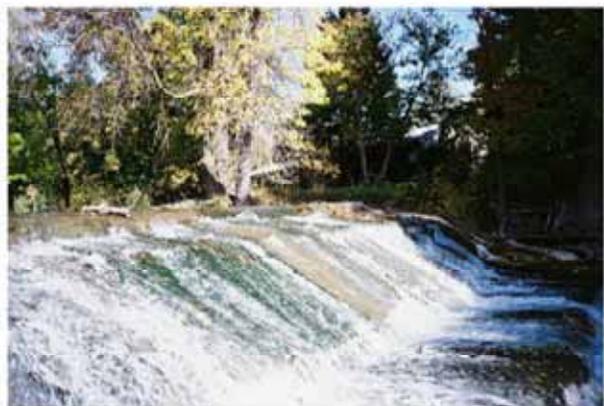
Name: 019_19
Date Modified: 11/1/2005 10:05:32 AM
Date: 10/31/2005 10:56:20 AM
Description: Primary spillway looking East

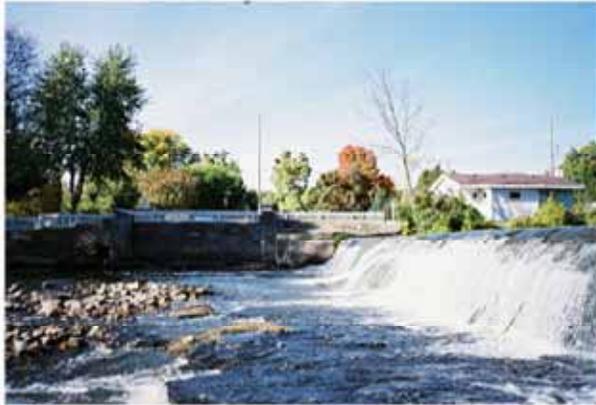
Name: 020_20
Date Modified: 11/1/2005 10:05:34 AM
Date: 10/31/2005 10:56:20 AM
Description: Primary spillway looking West

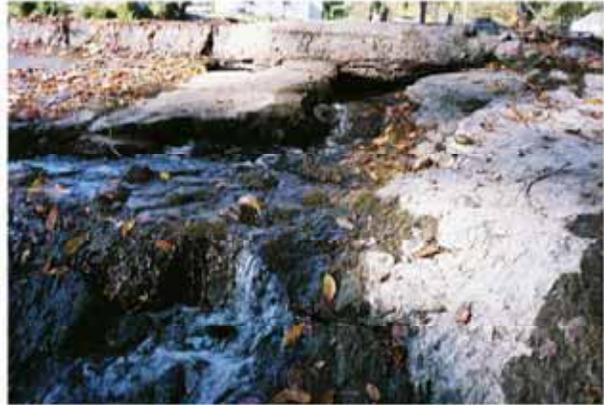
Name: 021_21
Date Modified: 11/1/2005 10:05:50 AM
Date: 10/31/2005 10:56:20 AM
Description: Deterioration and separation of concrete

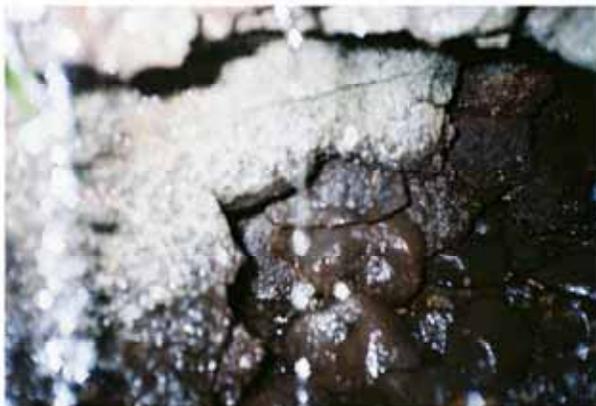
Name: 022_22
Date Modified: 11/1/2005 10:05:50 AM
Date: 10/31/2005 10:56:22 AM
Description: Deterioration of concrete

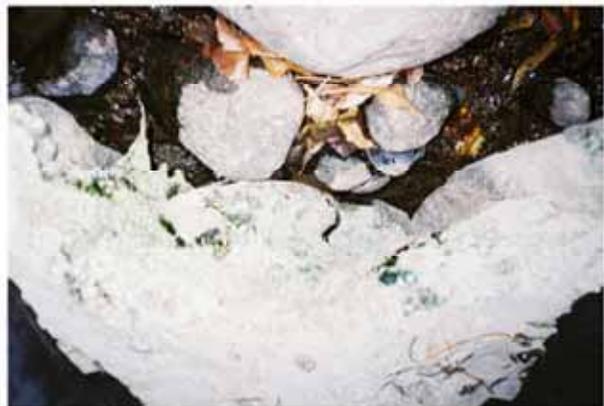
Name: 023_23
Date Modified: 11/1/2005 10:05:52 AM
Date: 10/31/2005 10:56:22 AM
Description: Seepage and deterioration of concrete

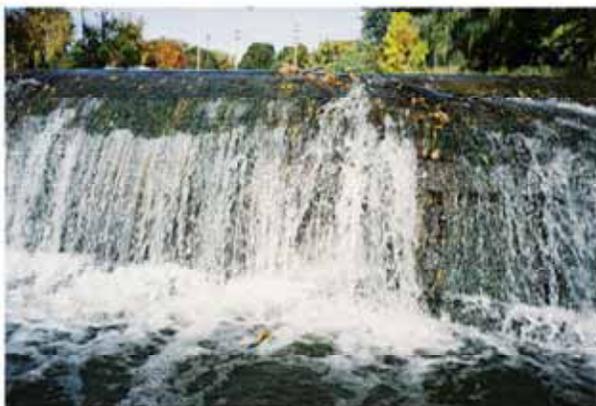
Name: 025_25
Date Modified: 11/1/2005 10:06:04 AM
Date: 10/31/2005 10:56:22 AM
Description: Primary spillway

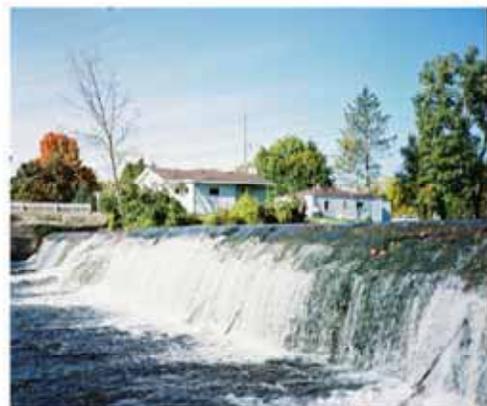
Name: 026_26
Date Modified: 11/1/2005 10:07:02 AM
Date: 10/31/2005 10:56:22 AM
Description: Primary spillway looking West
